New York State Department of Transportation

Yellow Flag NB23U4W012

BIN: 1065318

Location: Span 254, Girder G1 at Pier 254

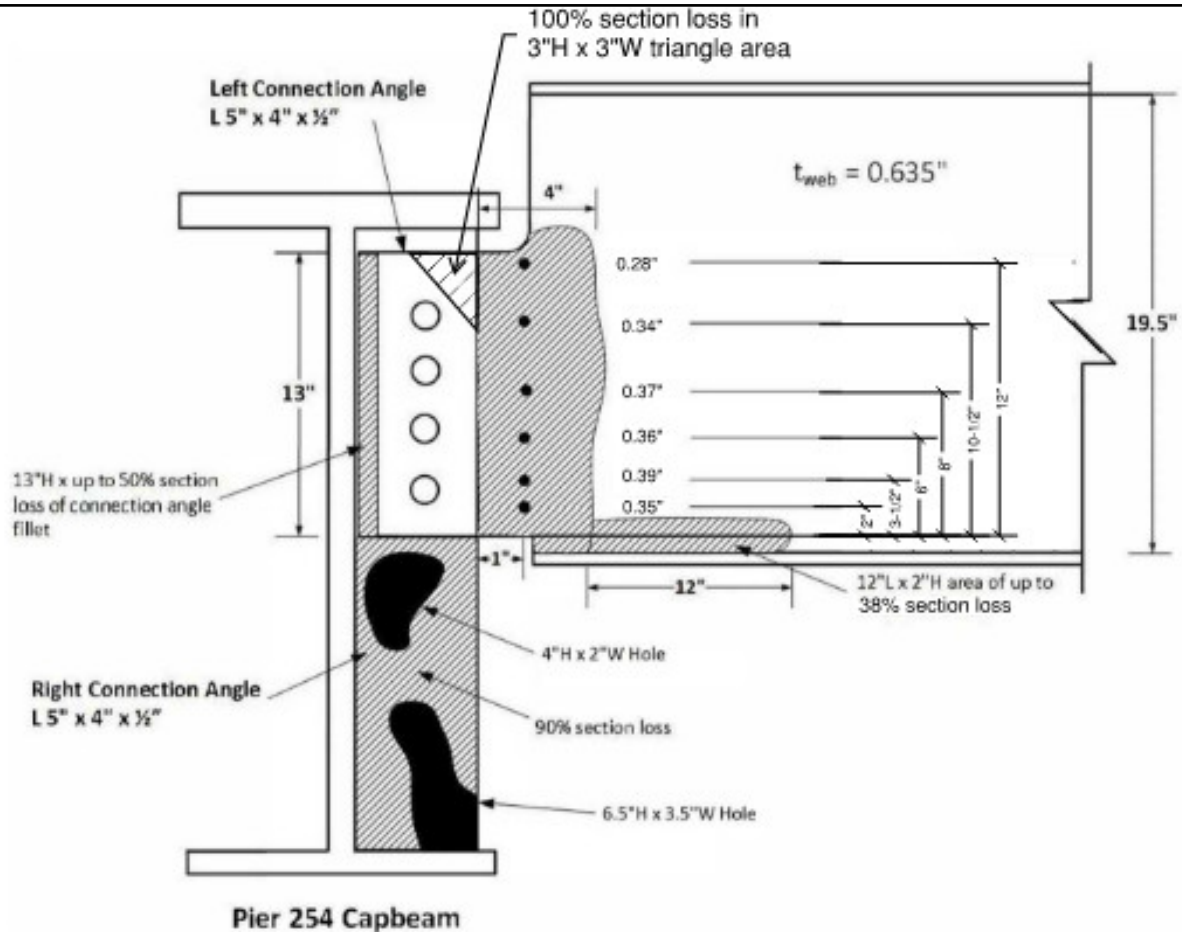
Photo Number: 2

Description: Girder G1 web along the connection angle exhibits 49% overall section loss for the full height of the web (previously noted to be 51%).

**Section Loss Calculations:**

Original Girder Web Thickness = 0.635" (as measured in the field)

As Built shearing web area = 13" H x 0.635" T = 8.255 sq. in.

Average remaining web section = $[0.28 \times 1.5] + [0.34 \times 2.5] + [0.37 \times 2] + [0.36 \times 2.5] + [0.39 \times 1.5] + [0.35 \times 2]$
 = 4.195 sq. in.

Web section loss – $((8.255 - 4.195)/8.255) \times 100\% = 49.18\%$ SAY = 49%

SKETCH FOR YELLOW # NB23U4W012
SPAN 254, GIRDER G1 AT PIER 254
(LOOKING RIGHT)
N.T.S

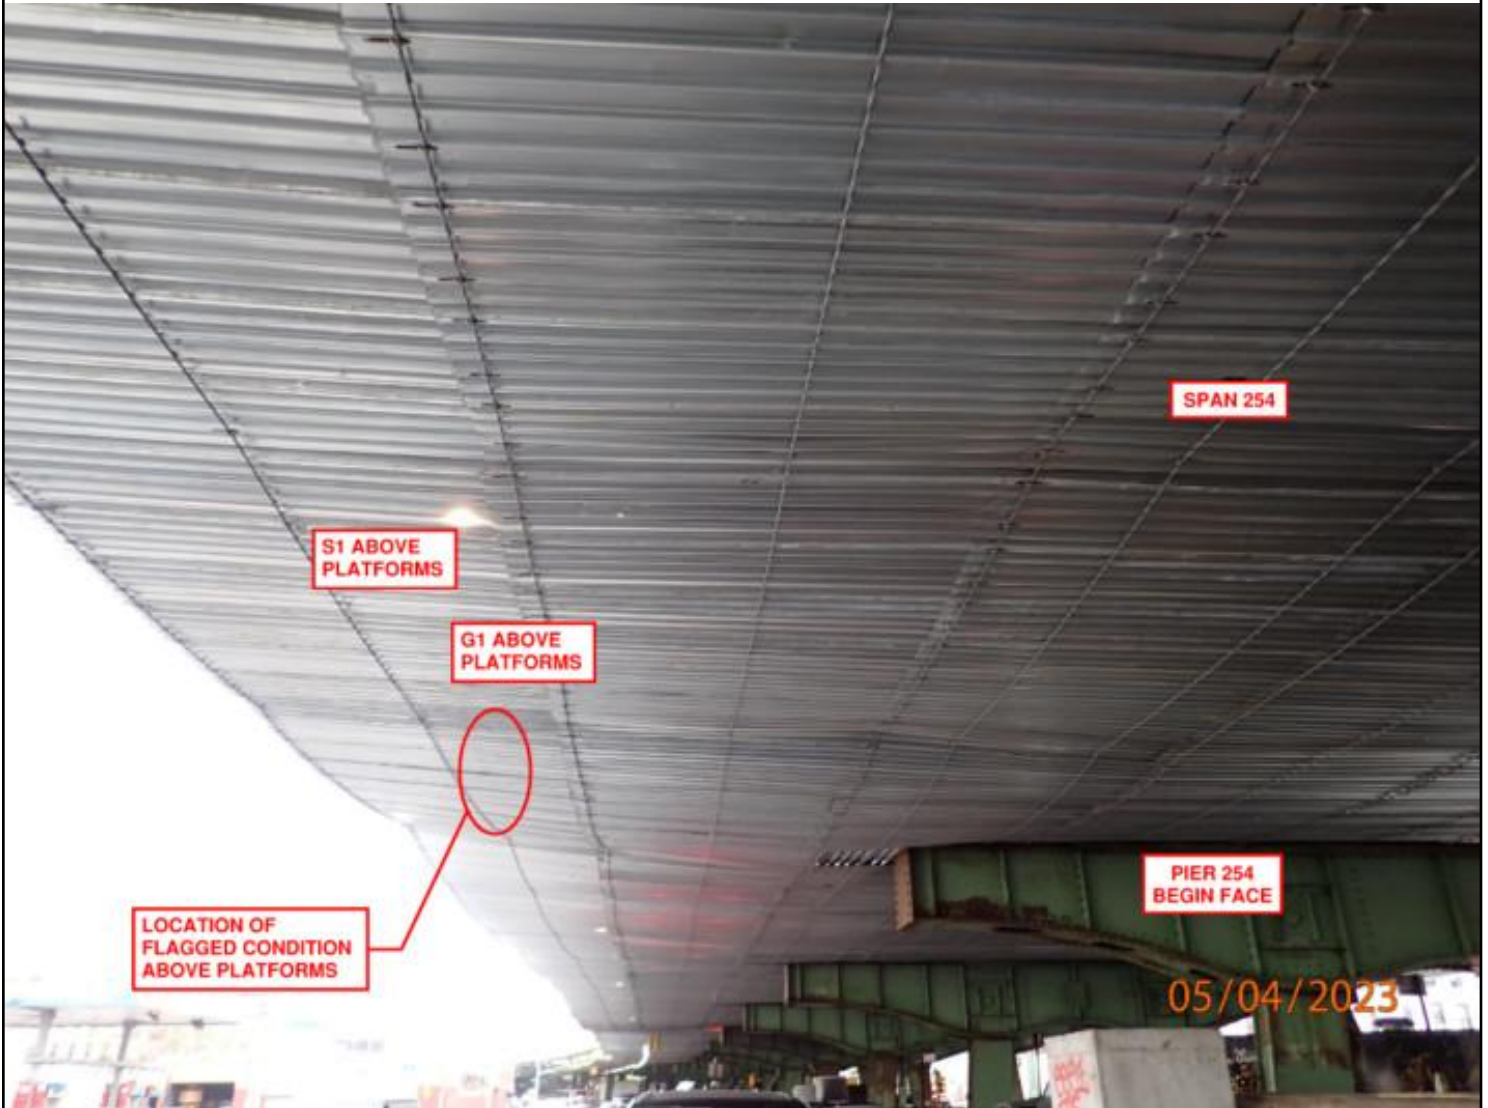
Photo Number: 3

Attachment Description: Span 254, Girder G1 at Pier 254. General view of the flagged location at Pier Cap connection, above platforms. Looking End-Up.

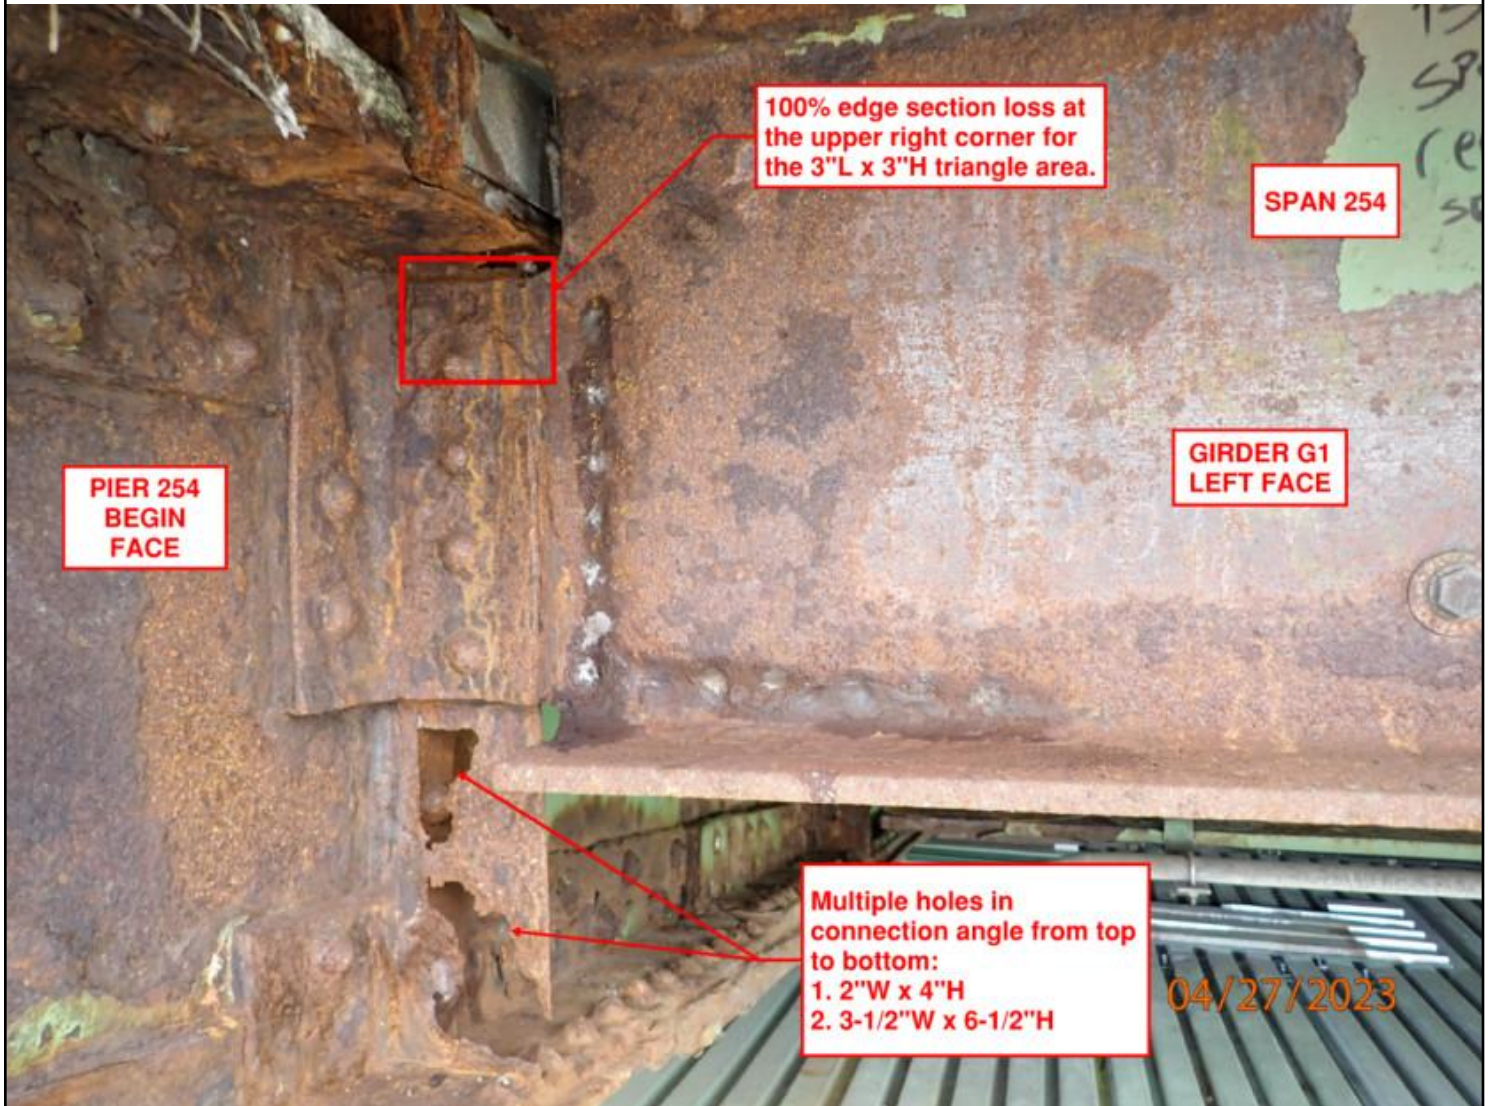
Photo Number: 4

Attachment Description: Span 254, Girder G1 at Pier 254. Close-up view of Girder G1 showing heavy section loss to the web of the Girder and corrosion holes in connection angle. Looking End-Right.

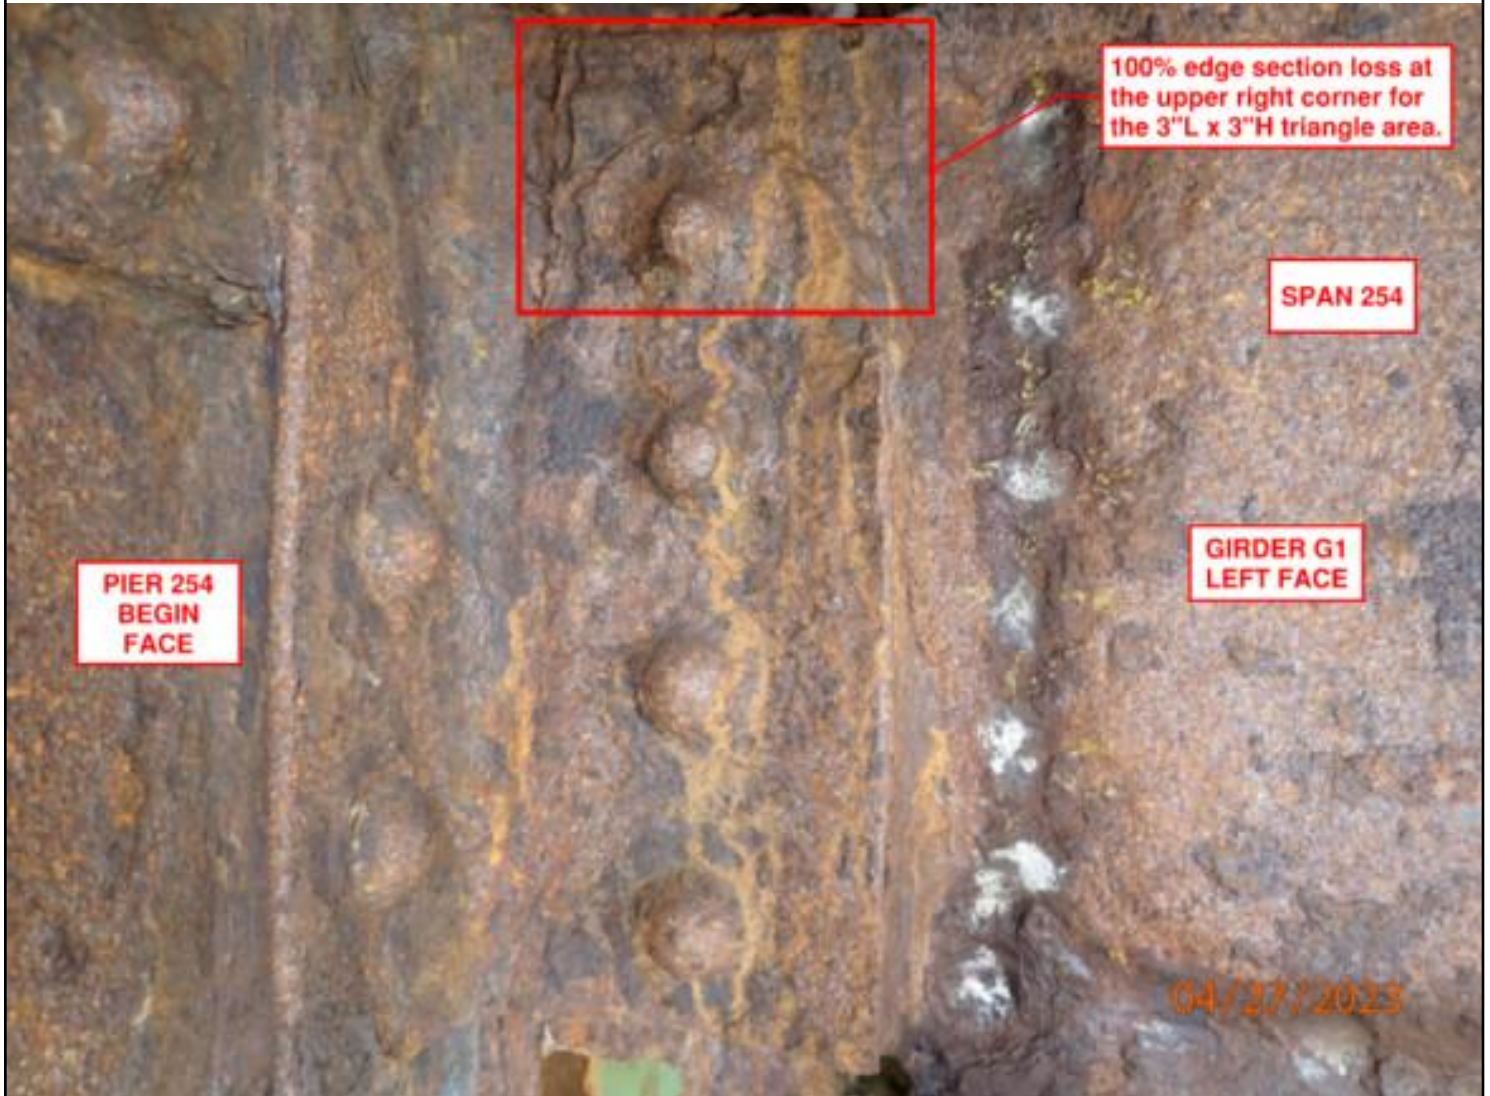
Photo Number: 5

Additionally, the left connection angle exhibits up to 50% section loss along the fillet (no change from previous) and 100% edge section loss at the upper right corner for 3"L x 3"H triangle area (no change). The right connection angle of Girder G1, along the web of the girder, (from the bottom cope of the web of Girder G1 to the top cope of the web of Girder G1), is in good condition with minor corrosion (less than 10% section loss) and pack rust at the top. The right connection angle below the bottom cope of the Girder G1 web exhibits up to 90% section loss with two corrosion holes measuring 4"H x 2"W and 6.5"H x 3.5"W (no change). The lower web of the girder, above the bottom flange near the connection to the pier exhibits 38% section loss (previously noted to be 35% section loss) along bottom flange over an area of 12"L x 2"H.

Attachment Description: Close-up view of 100% edge section loss at the upper right corner for 3"L x 3"H triangle area. Looking End-Right.

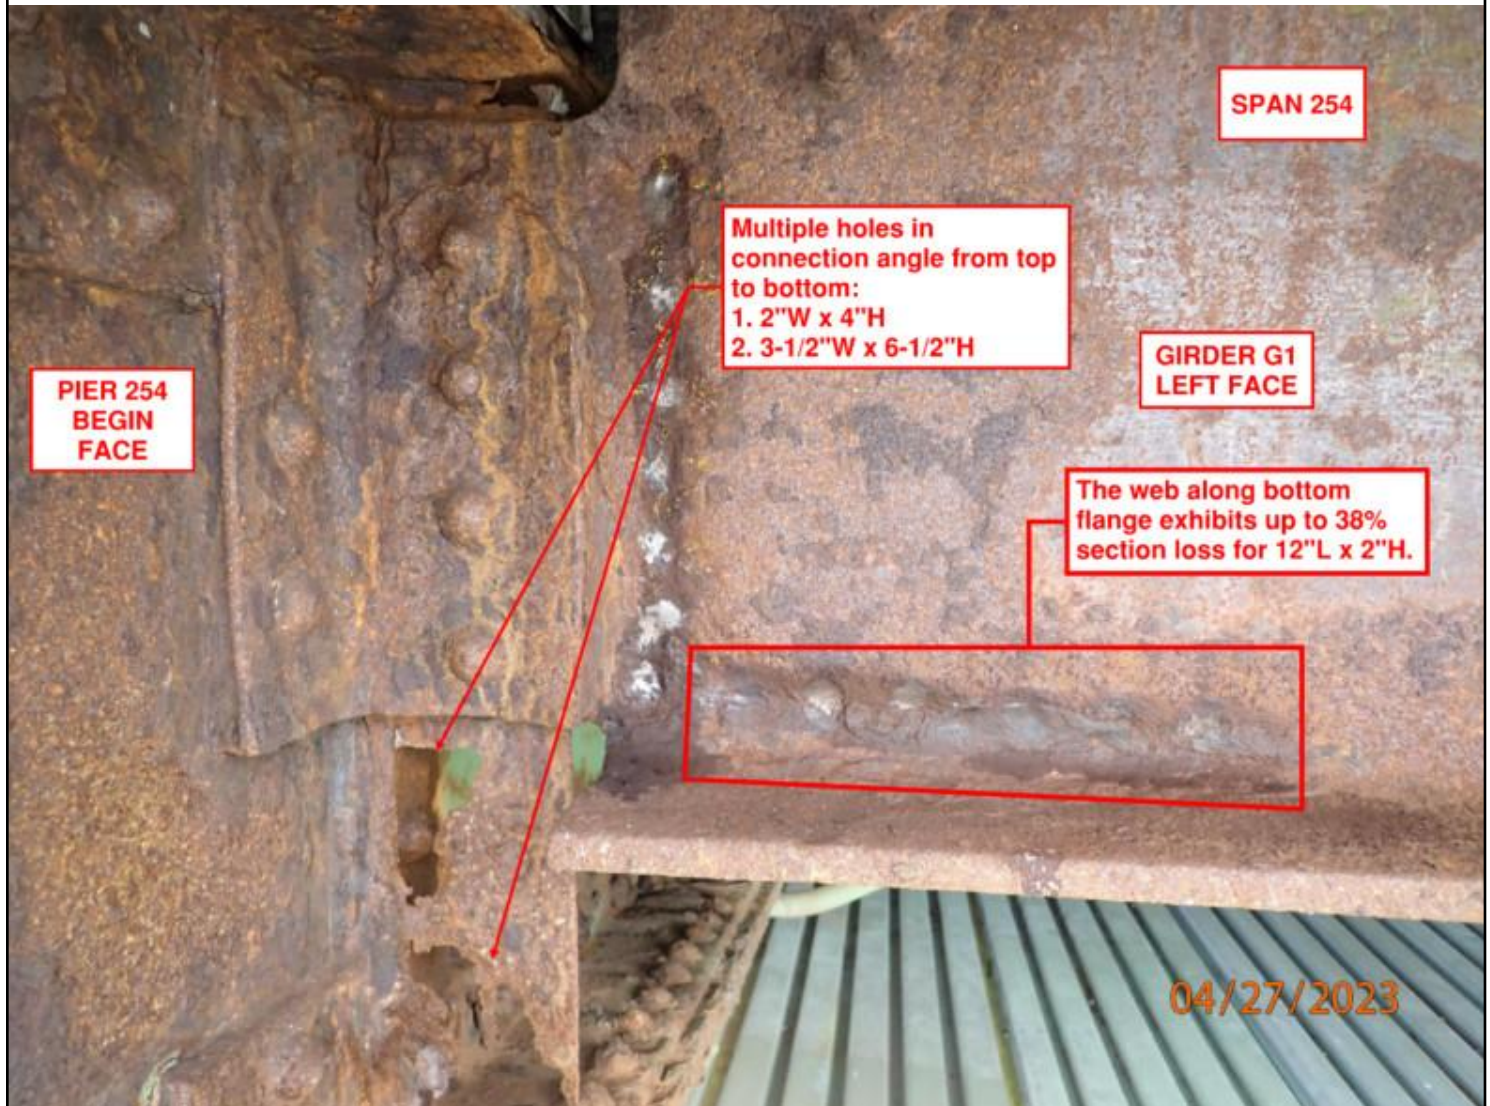
Photo Number: 6

Attachment Description: Close-up view of the right connection angle that exhibits two corrosion holes measuring 4"L x 2"H and 3.5"W x 6.5"H. In addition, the web along bottom flange exhibits up to 38% section loss for 12"L x 2"H area. Looking Right.

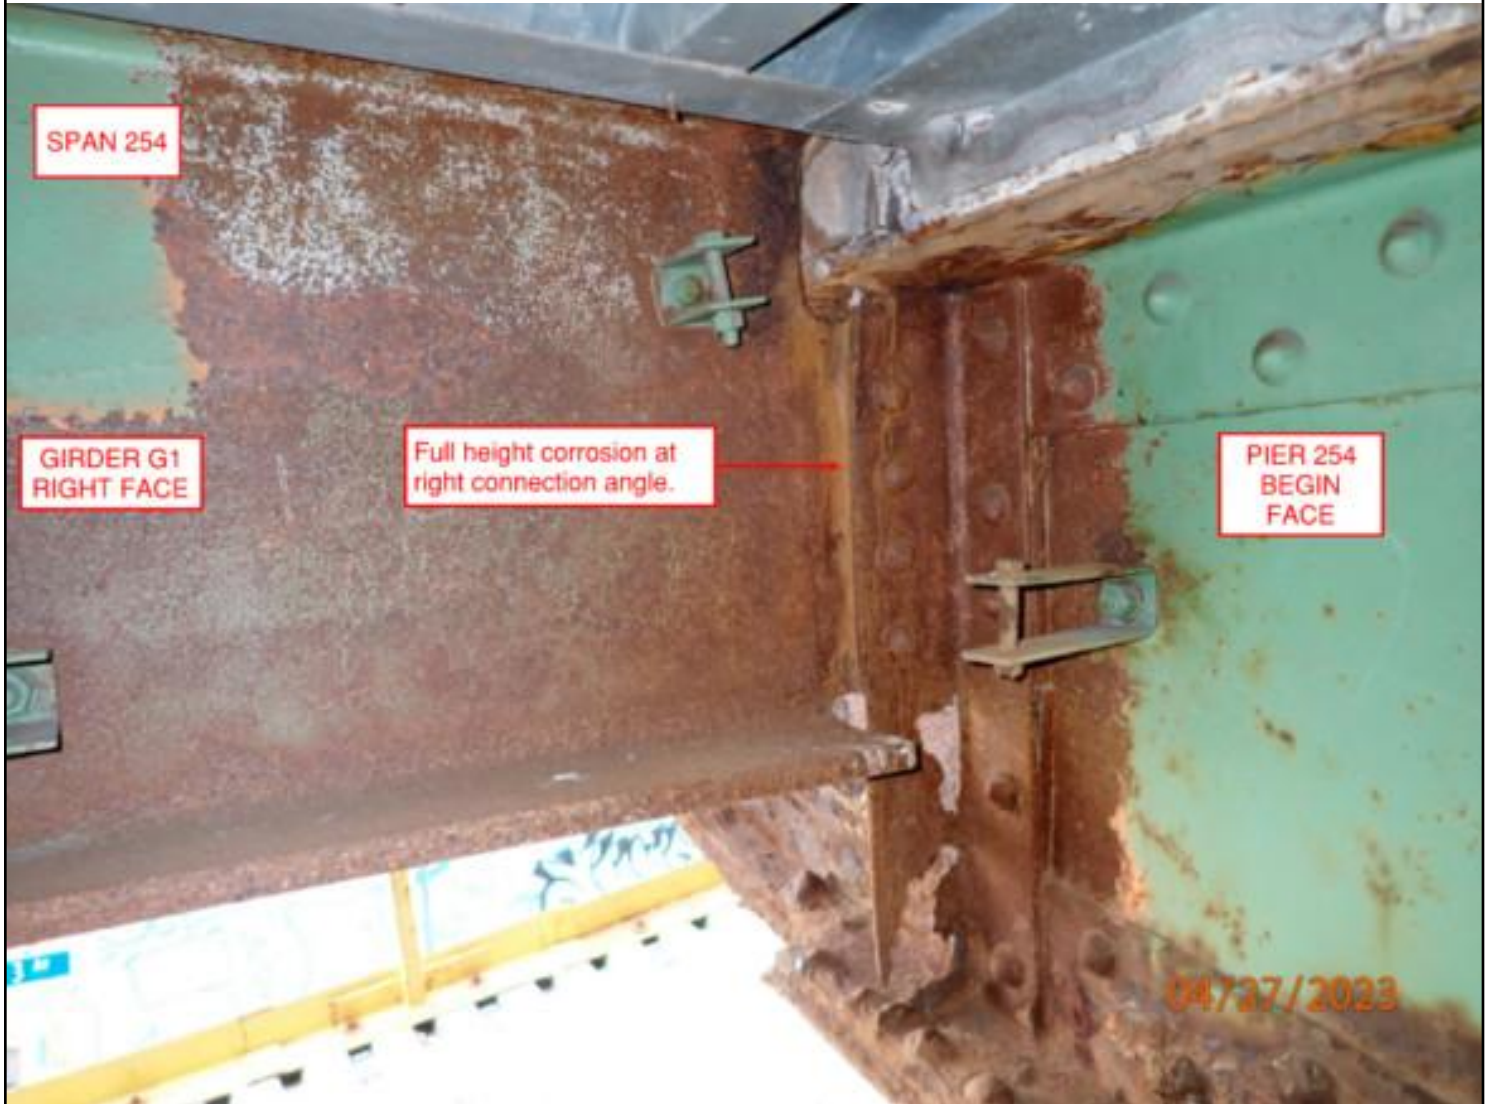
Photo Number: 7

Attachment Description: General view of Girder G1 right side web and connection angle. The web exhibits full height section loss. Looking End-Left.
